Oquaga Lake Sewer District Collection System Improvements

Town of Sanford, Broome County, New York

Engineering Evaluation and Map and Plan

December 2011

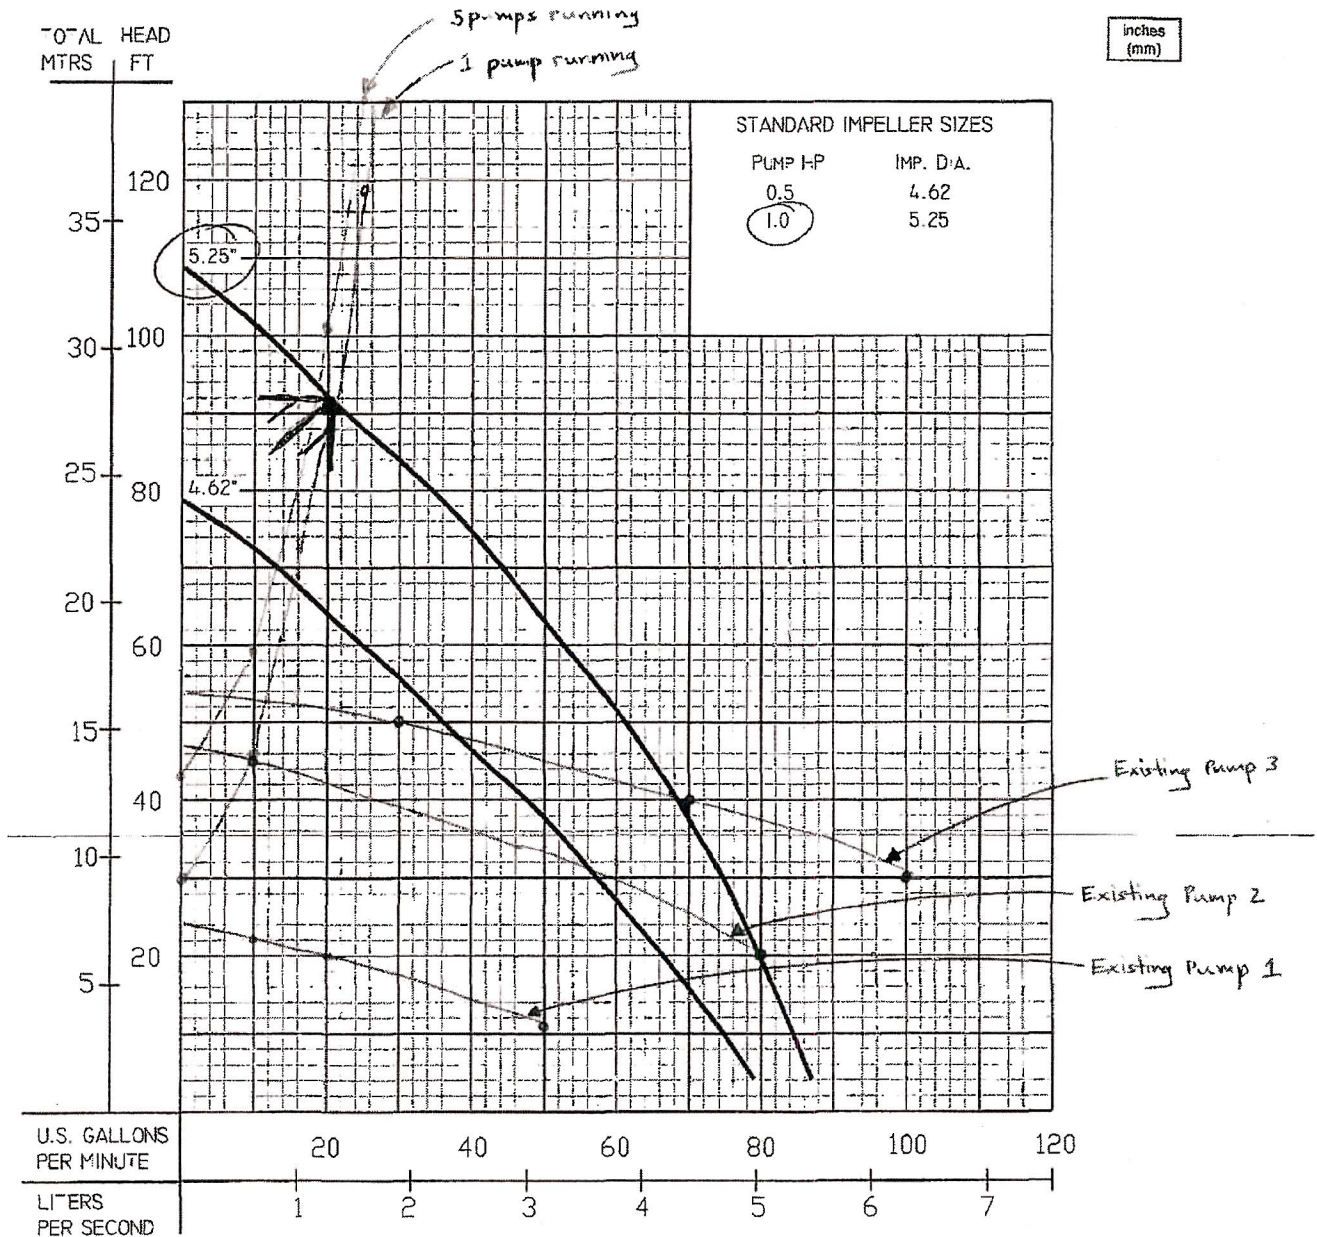
Oquaga Lake Road System

It was determined that the existing small diameter force mains are not undersized. It was also determined that replacement pumps selected by the DPW were good choices based on the hydraulics of the system and individual pump curves. The DPW is replacing the existing smaller capacity pumps (labeled "Pump Type 1 and 2" on the original construction plans) with 0.5HP pumps and the larger capacity pumps (labeled "Pump Type 3" on the

Existing Pumps

construction plans) with 1.0HP pumps. Based on the hydraulic modeling, this appears to be good practice and this general process is recommended as pump replacement continues. The hydraulic modeling results are included in appendix A.

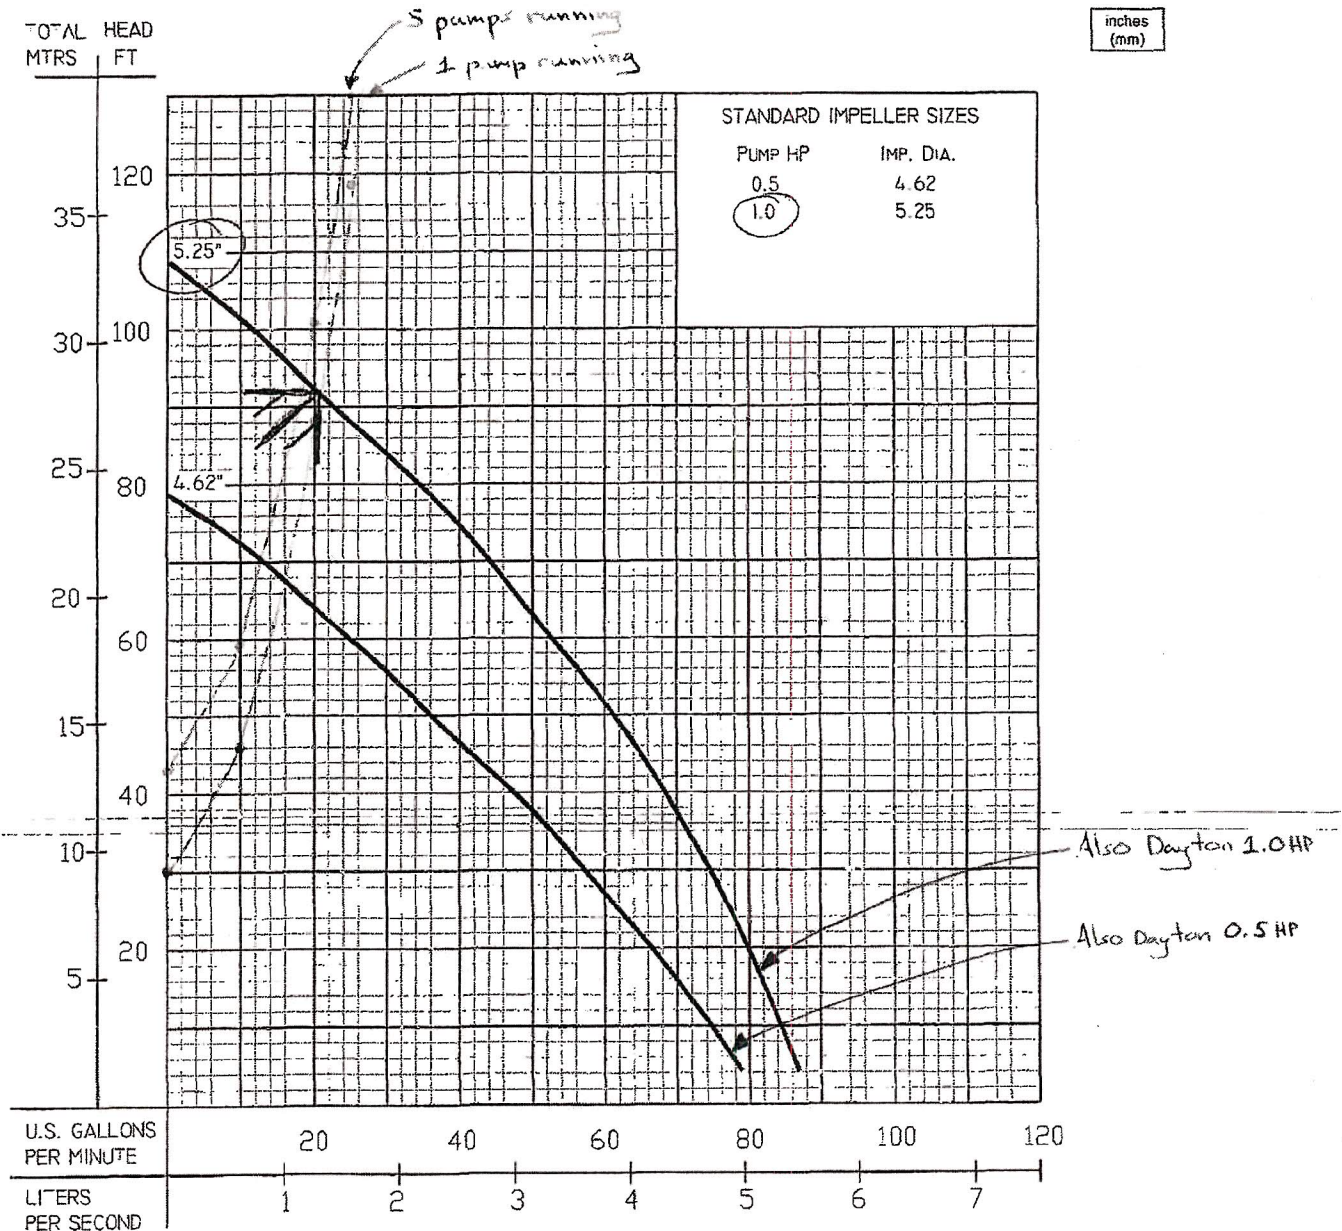
Oquaga Lake Road System

Proposed pumps

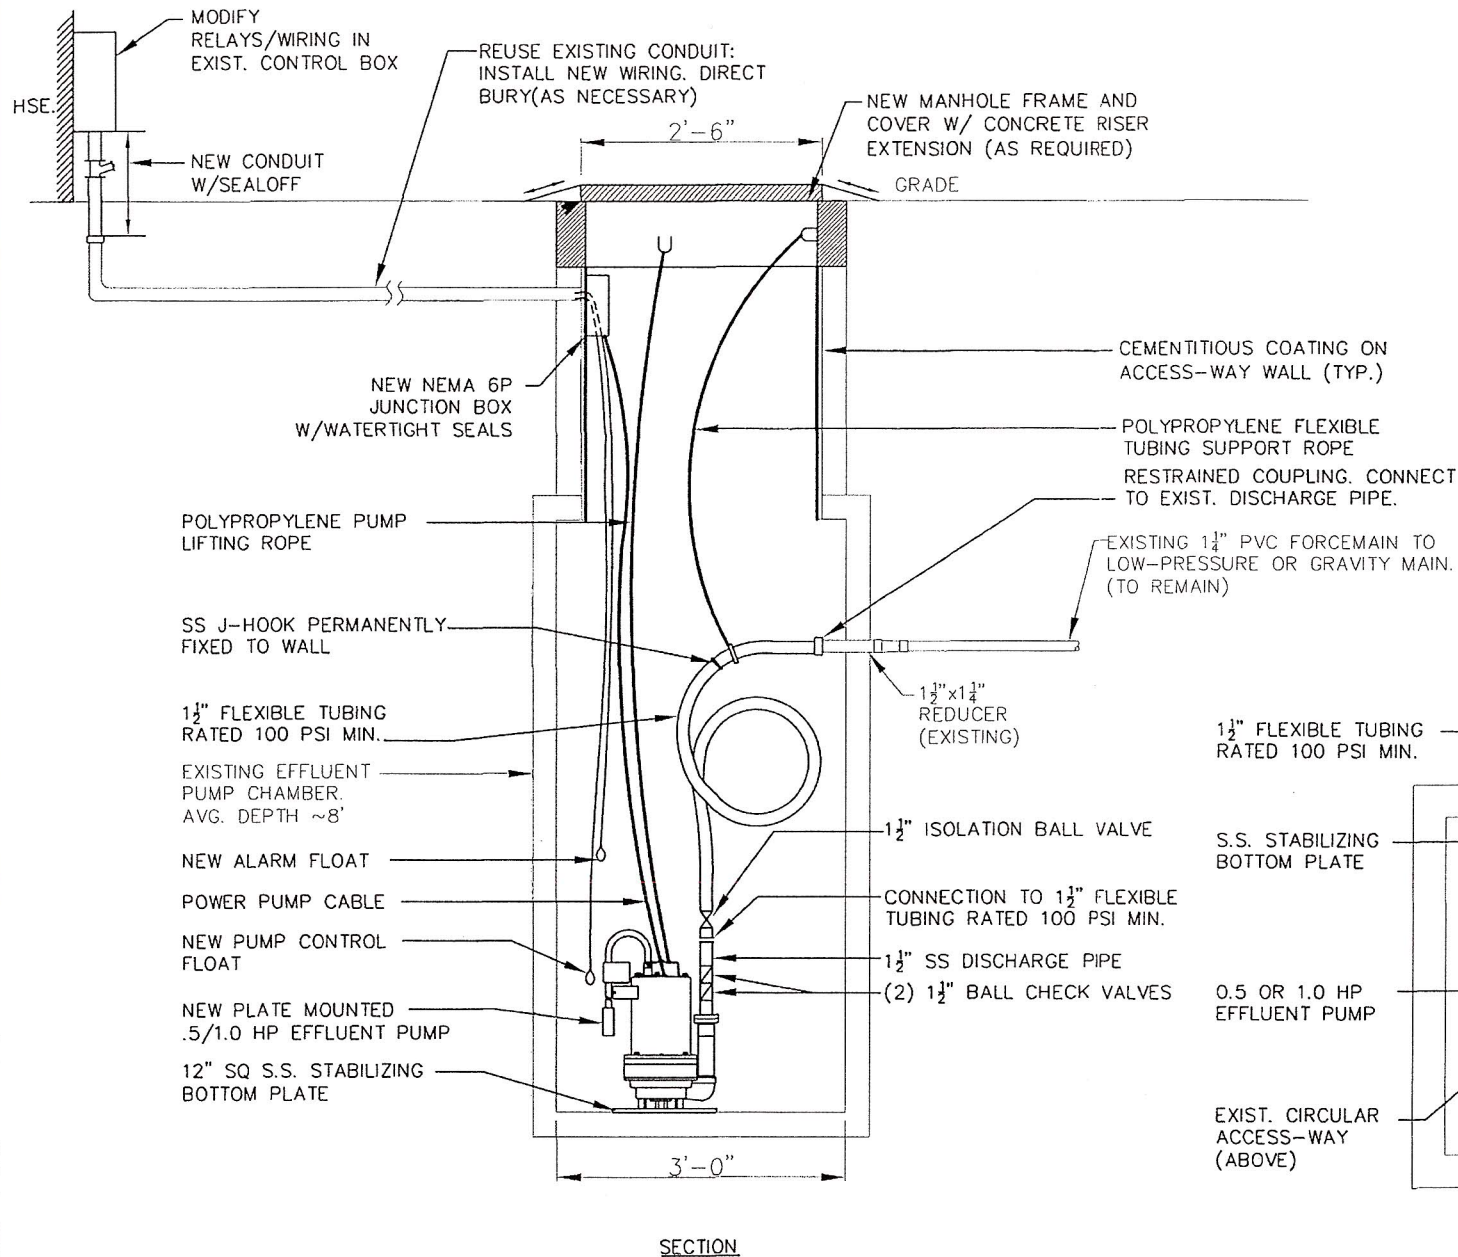
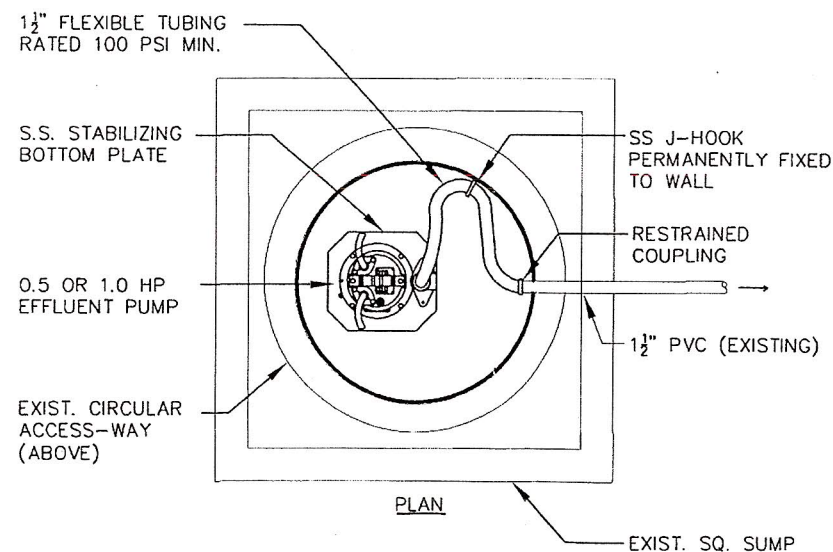
Figure Number
SK-1

In order to replace or perform maintenance on these pumps, a DPW employee must enter the confined space of the wet well to disconnect a PVC union fitting in the discharge piping. A polypropylene rope is then used to remove the pump and part of the discharge piping from the wet well.

The discharge piping in the wet wells is glued PVC with minimal thrust restraint. The piping was originally supported by a thrust restraint bar anchored into the wet well wall, but many of these steel supports have corroded to the point of failure, allowing some of the PVC joints to pull apart during pumping. The DPW has repaired and/or replaced the PVC fittings in kind on an as-needed basis.

The conductors are corroding to the point of failure, most likely due to the unsealed junction box within the wet well which allows the conductors to be exposed to corrosive hydrogen sulfide gases and high humidity within the wet well. While replacing corroded wires, the DPW has also found that the buried conduit is broken and separated in some locations, which makes it impossible to pull new conductors through.

To alleviate the confined space entry concerns, it is recommended that the Town retrofit the pump discharge piping to allow the pump to be removed without a person entering the wet well. A sketch illustrating the recommended configuration is included in appendix B; this configuration precludes the use of traditional, more costly rail mounted pumps in each wet well.

While diagnosing alarm conditions over the past several years, the DPW has found that many of the problems are associated with the electrical equipment, not the pumps. To alleviate these recurring problems, it is recommended that all conductors (wires) be replaced between the control panel and the wet well, as well as the electrical components within the panel and wet well. If the buried conduit is broken or too deteriorated to allow for new conductors to be pulled, new direct bury conductors or installation of new conduit may be used. A new fully sealed NEMA 6P rated junction box should be installed inside the wet well to prevent any of the hydrogen sulfide gas from corroding the new conductors.

The existing control panels are generally in good condition, but the relays are becoming difficult to locate and have become extremely expensive. These relays should be eliminated from the system. After discussion with the Town, it is recommended that the existing control panels be salvaged and reused, wherein internal modifications would be made to replace deteriorating electrical equipment and eliminate the expensive relays. A schematic sketch of the proposed improvements is provided in appendix C as guidance to the Town.

FLEXIBLE TUBING SHALL BE OF SUFFICIENT LENGTH TO ALLOW THE PUMP TO BE REMOVED AND SET ON THE SURFACE BEFORE BEING DISCONNECTED FROM THE SS PUMP DISCHARGE PIPE.
